**Existing Conditions**

# Highline College Master Plan Existing Conditions

# 2.4 FACILITY CONDITION SURVEY

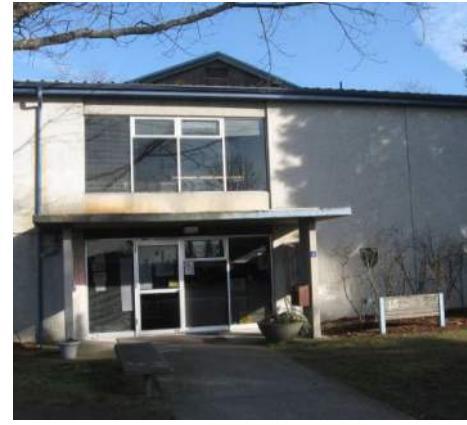
**BUILDING 15: TYPICAL FACULTY OFFICE BUILDING**

Thirteen of the original campus buildings are under 10,000 sf. With very little interior space, many of these buildings do not have internal corridors or common spaces. Studies show that as much as half of all learning occurs informally, outside the classroom. Lack of these spaces mean that these buildings fail to foster the social and collegial interaction typically desired in institutions of higher education. Students often must change buildings for each class, leaving little time for this important interaction to occur. Programs that could benefit from collocation with other programs are not possible in the current configuration. Furthermore, faculty are separated from the spaces where they teach and interact with students because buildings are too small to accommodate both.

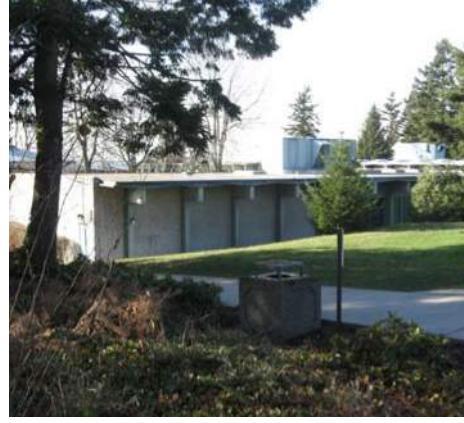
**MULTIPLE ROOF FAILINGS**

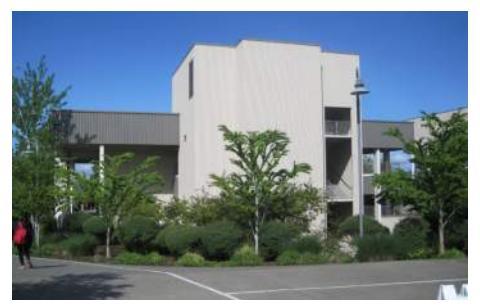
**BUILDING 23**

Building 23 temporarily housed the Nursing & Respiratory Care programs while Building 26 was renovated in 2018-20. The 3rd floor will be renovated for faculty office space as the college's Minor Improvement Project in 2022-23. Faculty office space will move from Building 15 to prepare it to be demolished with the construction of the new Welcome Center in 2025-27. The outdated hydraulic elevator system was replaced with a new electric traction system and cab in 2022. Galvanized piping is failing in some interior areas and requires replacement and insulation. The building has exterior walkways, and no interior common spaces for informal learning to occur. Minimal windows limit daylight and views of Puget Sound and Olympic Mountains.

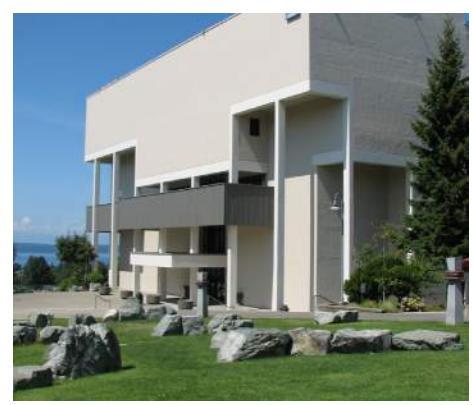
**BUILDING 25**

Building 25 is the library for the campus. It is the tallest building on campus at six stories. With the movement towards electronic books and periodicals, the library is under increasing pressure to expand the number of computer work stations available for students to use for their online research. The electrical system is at capacity, and it is increasingly difficult to accommodate new technology. Maintenance is unable to access the vertical victaulic pipe couplings, which poses problems in the event of leaking. Building 25's HVAC system has created repeated maintenance calls and is at the end of its useful life.

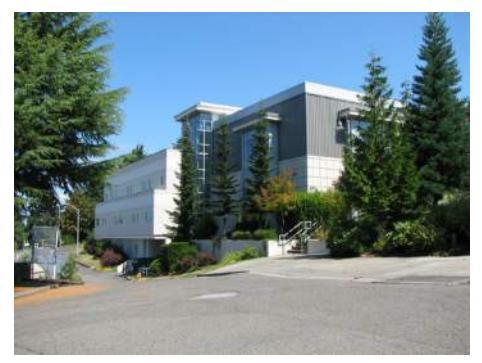
**BUILDING 30**

The Academic Technology Center, was completed in 1990 and remodeled in 2000. Some windows are leaking, and the north side chiller is nearing end of life that will need to be replaced in the next several years. Building 30 contains the equipment and resources that supports Students drop-in and computer laboratories use for the College as well as the online instructional programs such as Canvas and the Instructional Computing Department staff offices. The exit at the north side of Building 30 from the 2nd floor poses accessibility

challenges due to the slope of the drive immediately adjacent to the existing landing. This building also has an elevator that will need to be replaced sometime in the future as parts are no longer available or scarce.

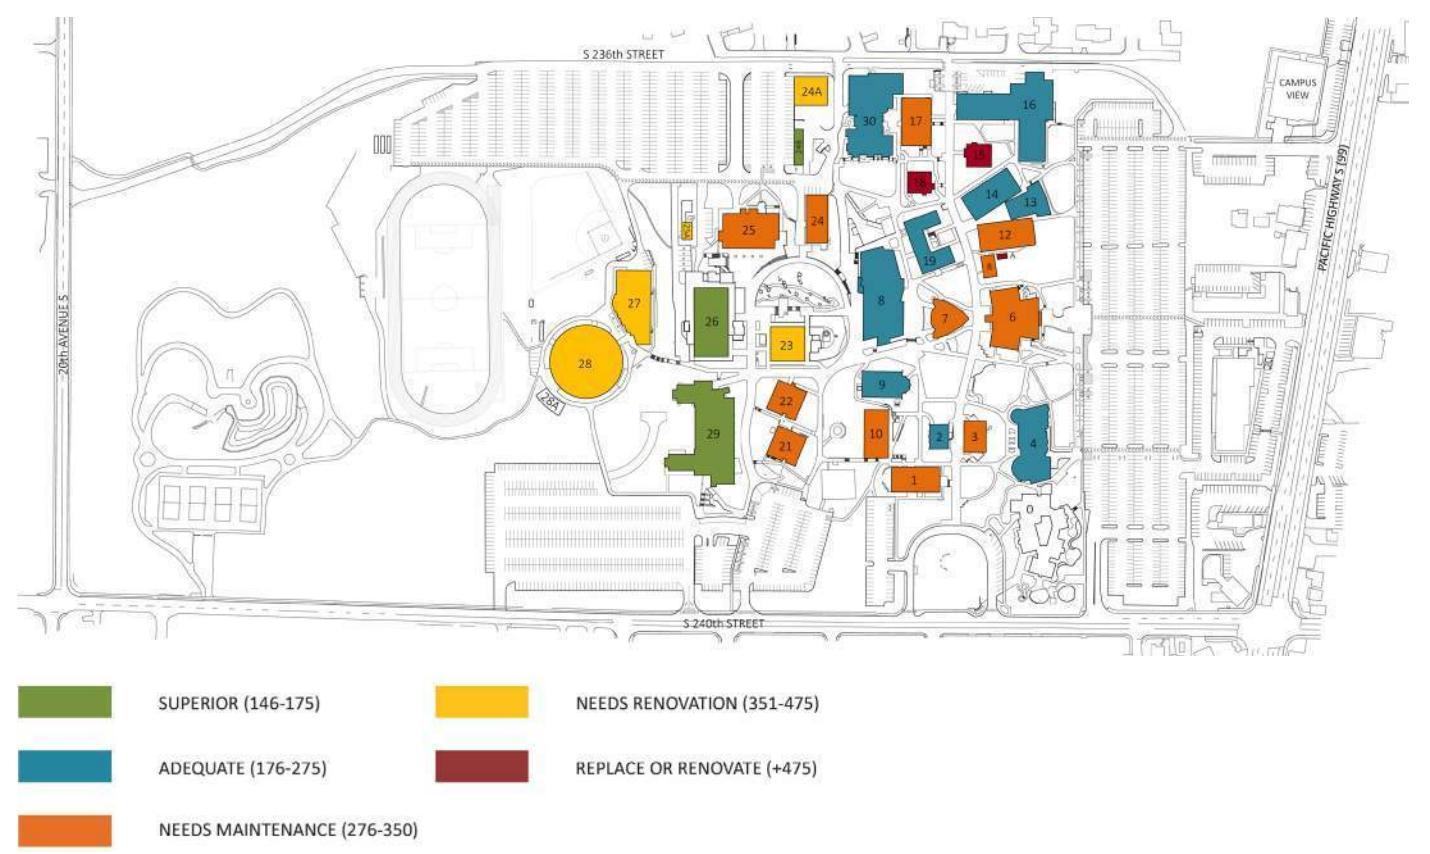
## 2021 BUILDING CONDITION DIAGRAM

The State Board of Community and Technical Colleges (SBCTC's) 2021 Facility Condition Survey (FCS) reviewed the entire campus, listed deficiencies, and rated their severity in a published report. The FCS report is used by the SBCTC and the Legislature in determining capital funding appropriations.

The following table lists the buildings' conditions ranked in order of worst condition to best based on the 2021 Facility condition survey and compares the same buildings' scores in previous FCS reports. The higher the score, the worse condition the building is in. While the FCS is a useful tool to identify deficiencies in the physical condition of the building, the scores do not adequately reflect how well these buildings meet the programmatic needs of the College.

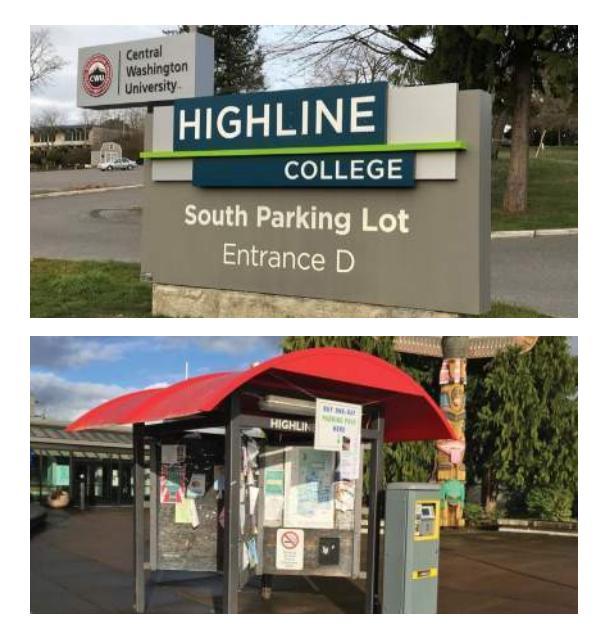
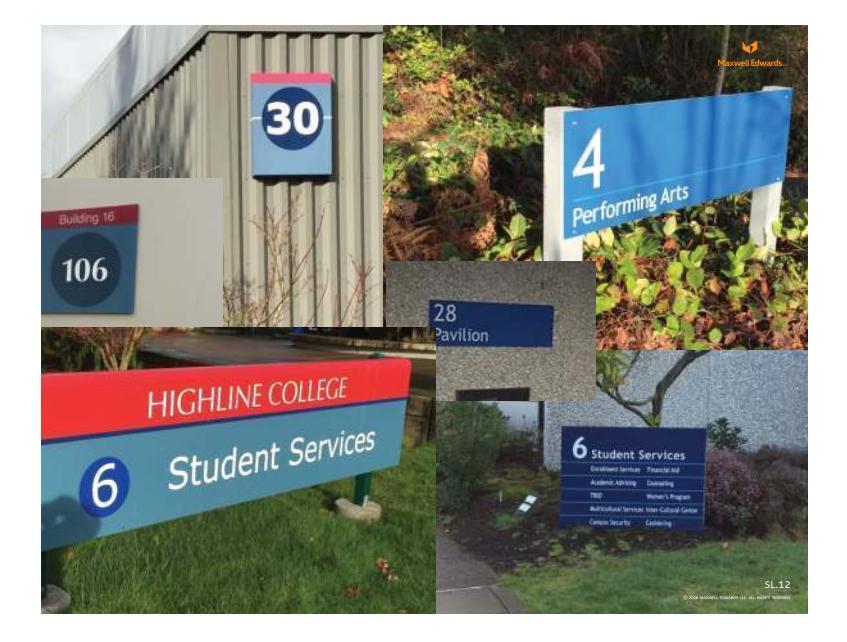
### **EXISTING CAMPUS SIGNAGE AND WAYFINDING**

The existing campus signage lacks hierarchy and consistency. The current informational directional signage could benefit by being simplified to campus map and key information. Building signage location, colors, and appearance should be of a similar language to unify the campus and assist with wayfinding.
