**Existing Conditions**

# Highline College Master Plan Existing Conditions

# 2.4 FACILITY CONDITION SURVEY

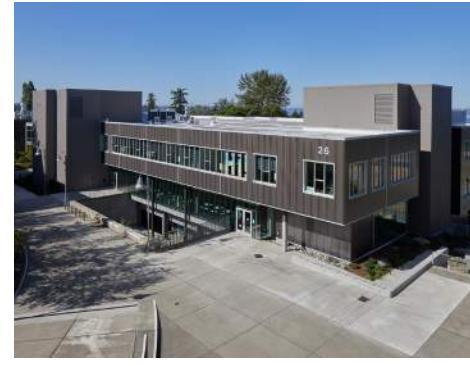
BUILDING 26

Building 23 temporarily housed the Nursing & Respiratory Care programs while Building 26 was renovated in 2018-20. The 3rd floor will be renovated for faculty office space as the college's Minor Improvement Project in 2022-23. Faculty office space will move from Building 15 to prepare it to be demolished with the construction of the new Welcome Center in 2025-27. The outdated hydraulic elevator system was replaced with a new electric traction system and cab in 2022. Galvanized piping is failing in some interior areas and requires replacement and insulation. The building has exterior walkways, and no interior common spaces for informal learning to occur. Minimal windows limit daylight and views of Puget Sound and Olympic Mountains.
